Application report

Date: 14.01.2014

Title: Analysis of semiconductor failures using Kleindiek EBIC/RCI amplifier and Zeiss Auriga

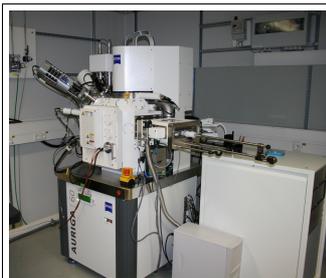
Figure1: Zeiss Auriga Dual Beam FIB/SEM

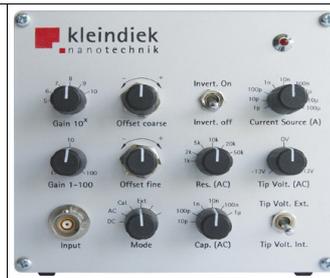
Figure3: Kleindiek EBIC/RCI Amplifier

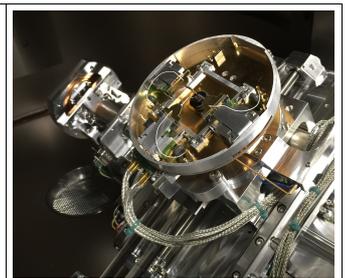
Figure4: Kleindiek Prober Shuttle

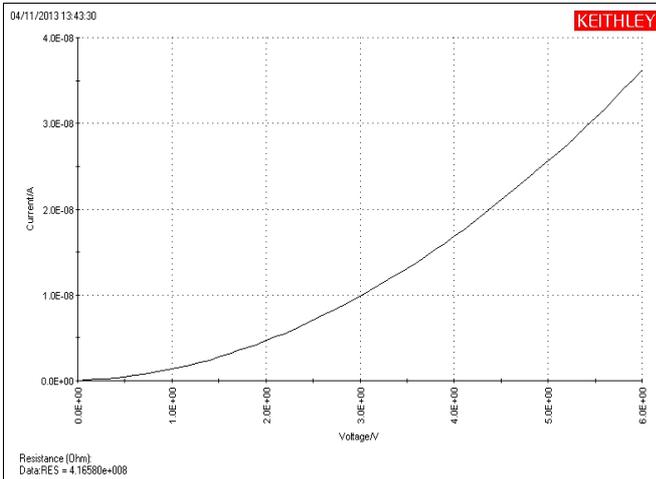
Figure5: Leakage current in nA range observed on capacitor test structures.

Yield loss caused by leakage currents in nA range on capacitor test structures (see Fig1). Already performed OBIRCH (Optical Beam Induced Resistance Change) and photon emission analysis did not yield any results on the affected devices.

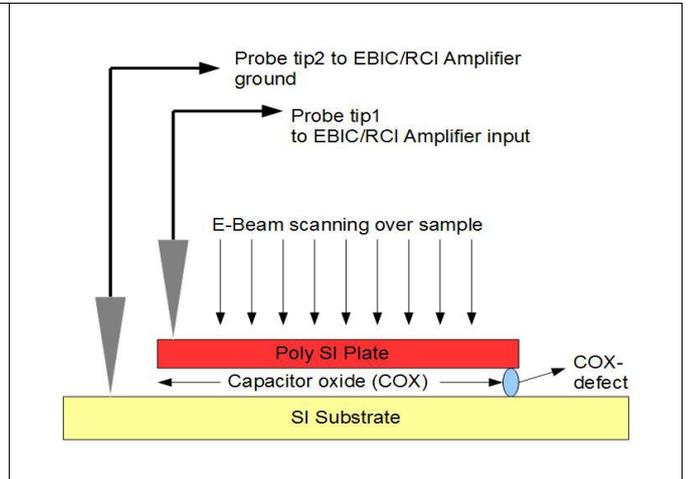
Figure6: Simplified schematic of measurement setup.

For the EBAC analysis on these devices the investigated capacitor structure was connected via 2 probe tips to the Kleindiek EBIC/RCI amplifier (see Fig6).

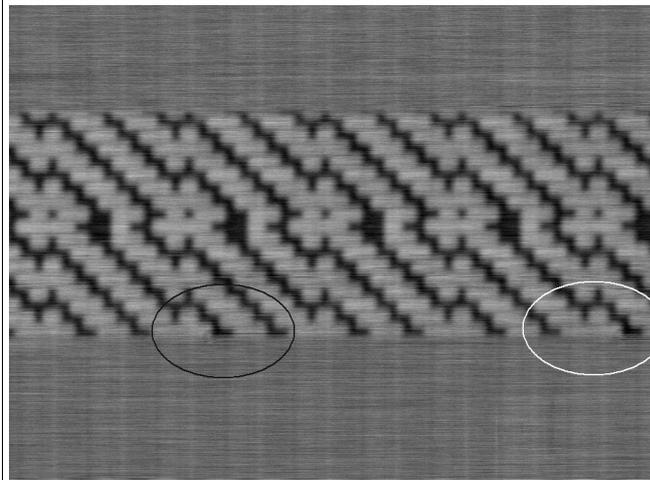
Figure7: First attempts yielded only very diffuse signals at the capacitor edges.

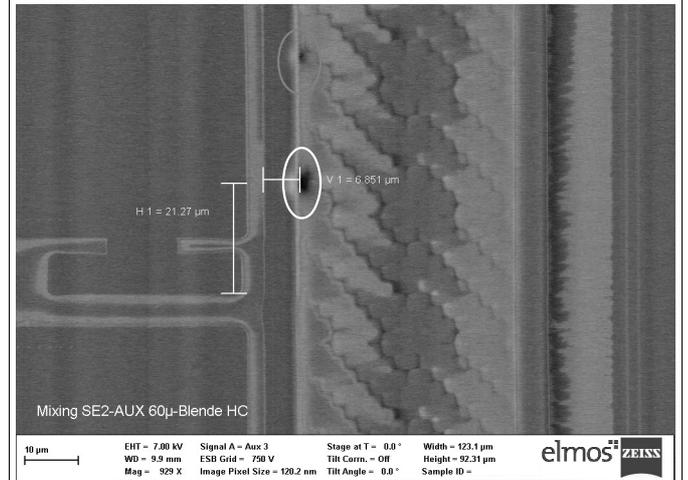
Figure8: Change of scanning direction showed massive increase in EBAC signal quality.

After gathering some experience with the influence of the different variable parameters it was easy to get high quality images suitable as a basis for further physical preparation steps (see Fig8+9).

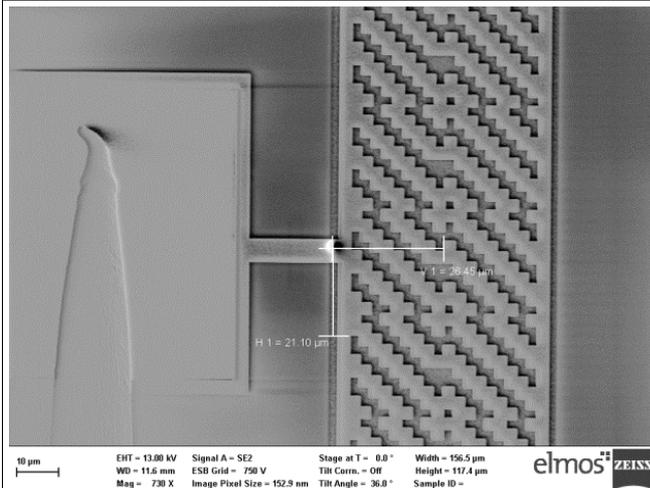
Figure9: Overlay image (EBAC + SE2) after parameter optimization (Amplifier+SEM) in another area of the capacitor test structure.

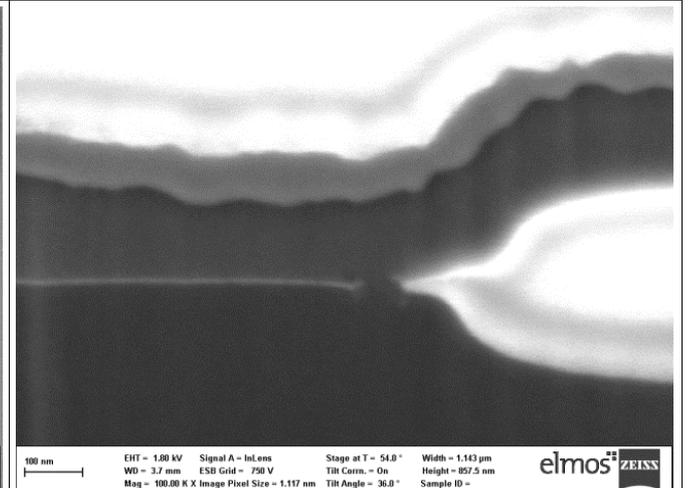
Figure10: FIB (Focused Ion Beam) cross section image of the localized failure site.

Furthermore the very precise localization compared to OBIRCH and photon emission analysis reduced the final preparation effort for time consuming cross section or STEM analysis at the physical failure site (see Fig10).

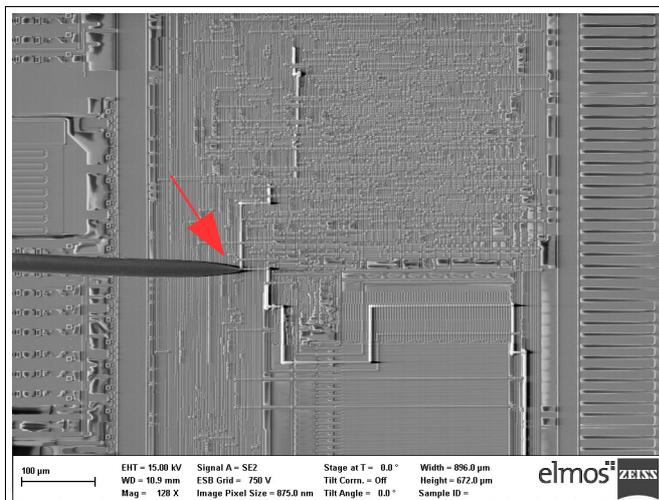
Figure11: Signal line routed on several metallization layers connected to EBIC amplifier via probe tip (red mark).

Figure 11 shows the EBIC image in DC mode of a device after connecting one internal signal line to the EBIC amplifier with a probe tip on metal4 layer. Depending on the used acceleration voltage the whole routing down to metal1 layer of this signal can be highlighted in the EBIC image.

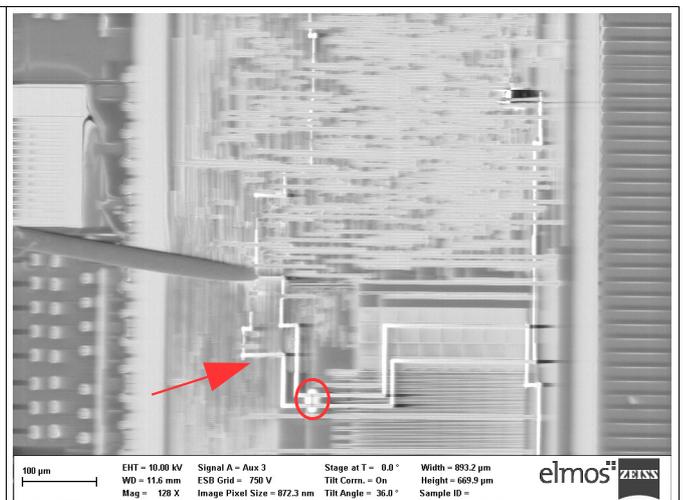
Figure12: Same signal line from figure11 shorted to a neighboring signal line. Area of the short and shorted signal are easily visible in the EBIC image (red marks).

Afterwards the sample was modified via FIB (Focused Ion Beam) so that the signal was shorted to another internal signal line by depositing a platinum bridge. The corresponding EBIC image of the modified sample can be seen in figure12.

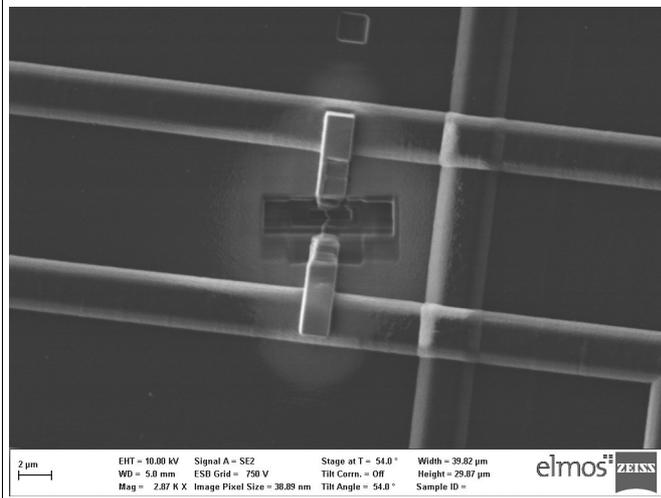
Figure13: FIB bridge milled down till it got high ohmic (approx. 24kOhms).

To check the sensitivity of the EBIC signal on the resistance between the two shorted signals the deposited platinum bridge was milled down till only a surface connection was left. This way the resistance of the original short was increased to approximately 24kOhms. In the EBIC image taken afterwards still both now high ohmic shunted signals and the location of the shunt are highlighted.

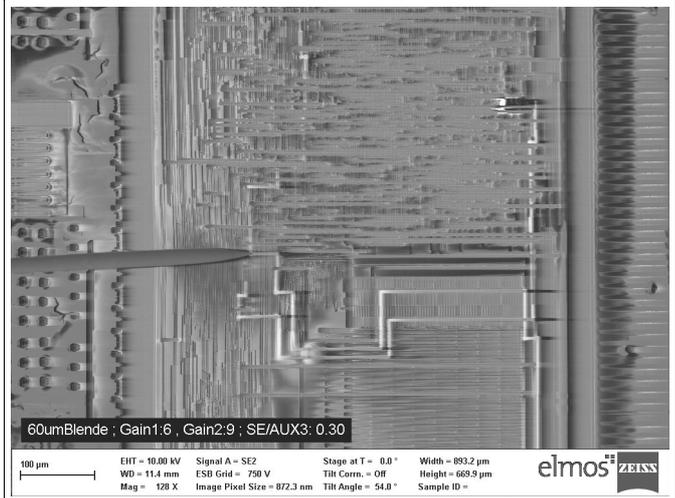
Figure14: Shunted signal and area of the high ohmic shunt are still visible.

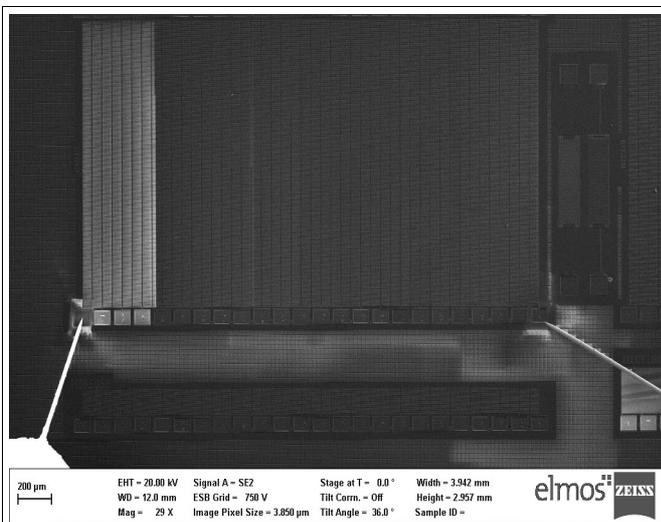
Figure15: Via chain with over 1.000.000 vias contacted with 2 probe tips.

As an example figures 15+16 show a high resistive via chain test structure. With EBIC/RCI analysis the failure site could be traced back to a single high ohmic via within the whole chain consisting of 1 million vias.

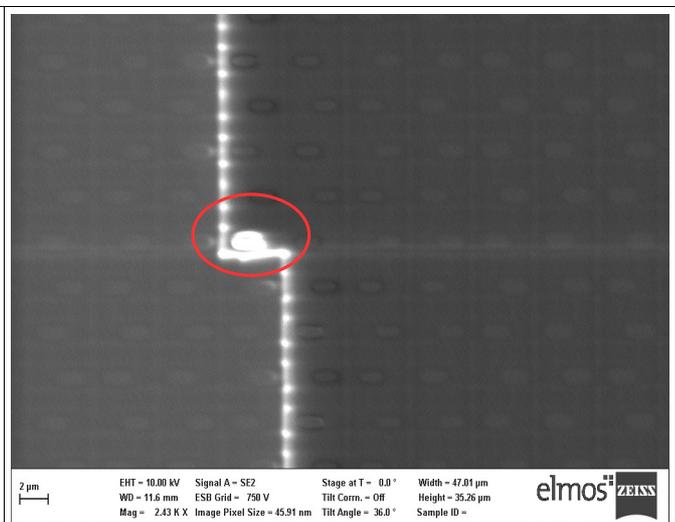
Figure16: Single high ohmic via highlighted in the EBIC/RCI image.

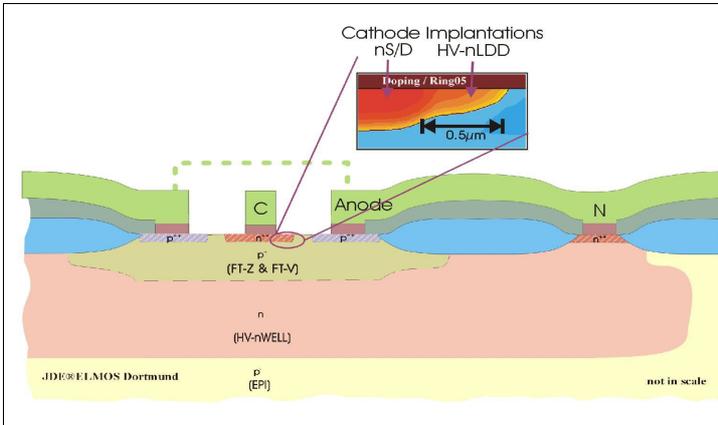
Figure17: Cross section with the different dopant regions in the investigated bipolar structure.

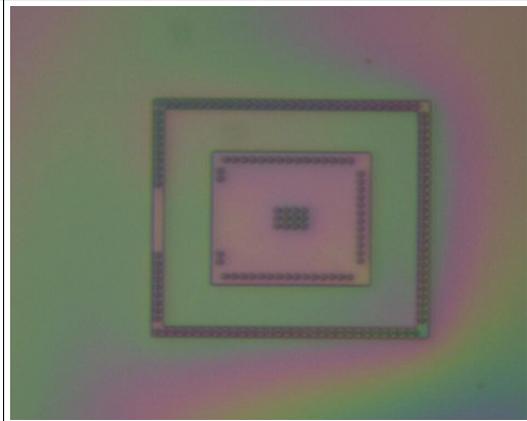
Figure18: Light microscope overview image of the parallel polished specimen down to contact level.

For best resolution the investigated device was delayered down to contact level. Two probe tips were used for EBIC image acquisition. This way misaligned dopant regions causing leakage currents could be detected in the past in cases where OBIRCH and photon emission analysis did not yield any results (see figures 22-24).

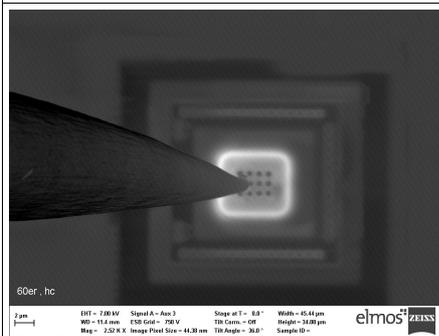
Figure19: EBIC image at 7kV

For EBIC imaging of dopant areas e.g. within bipolar structures or diodes the DC mode of the EBIC/RCI amplifier was used. By varying the acceleration voltage the dopant regions in different depths in the substrate can be visualized (see figures 19-21).

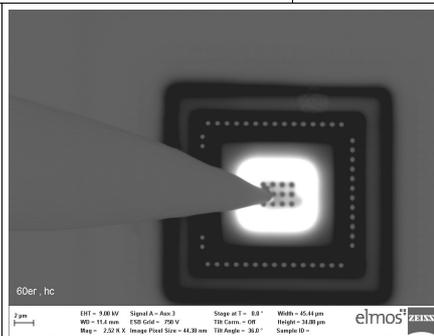
Figure20: EBIC image at 9kV

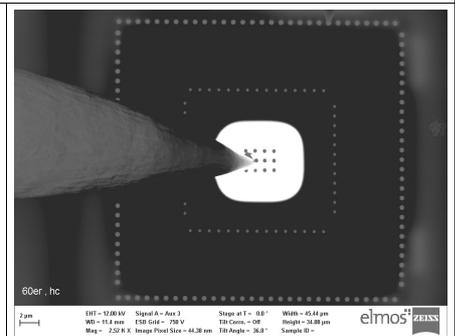
Figure21: EBIC image at 12kV

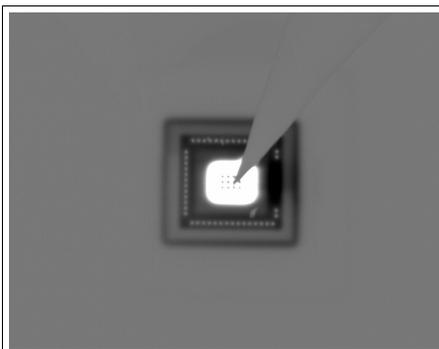
Figure22: Same EBIC analysis performed in the past on fail device at external lab. Image at 9kV acceleration voltage.

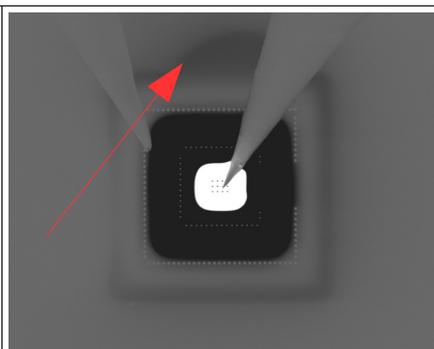
Figure23: EBIC analysis performed in the past at external lab. Fail device at 12kV acceleration voltage. Local deviation to a reference device visible.

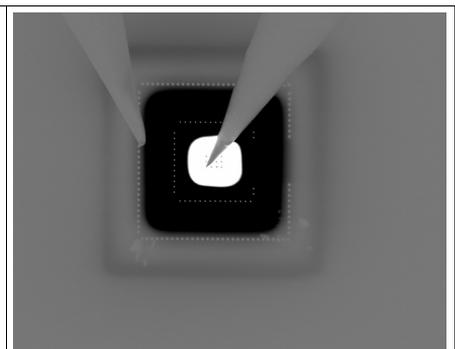
Figure24: Reference device at 12kV acceleration voltage.
